# Just Because You Can't See It...

## True Story:

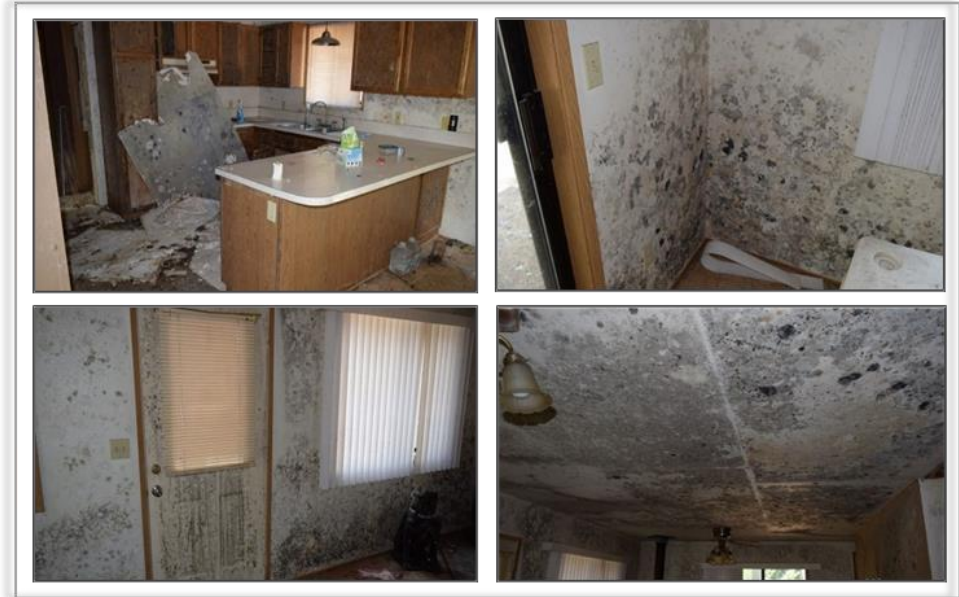
1

In April, we got a call from a local contractor who purchased a mold-infected house in Yelm. He needed us to perform an Indoor Air Quality (IAQ) Test to certify the air was safe for workers.

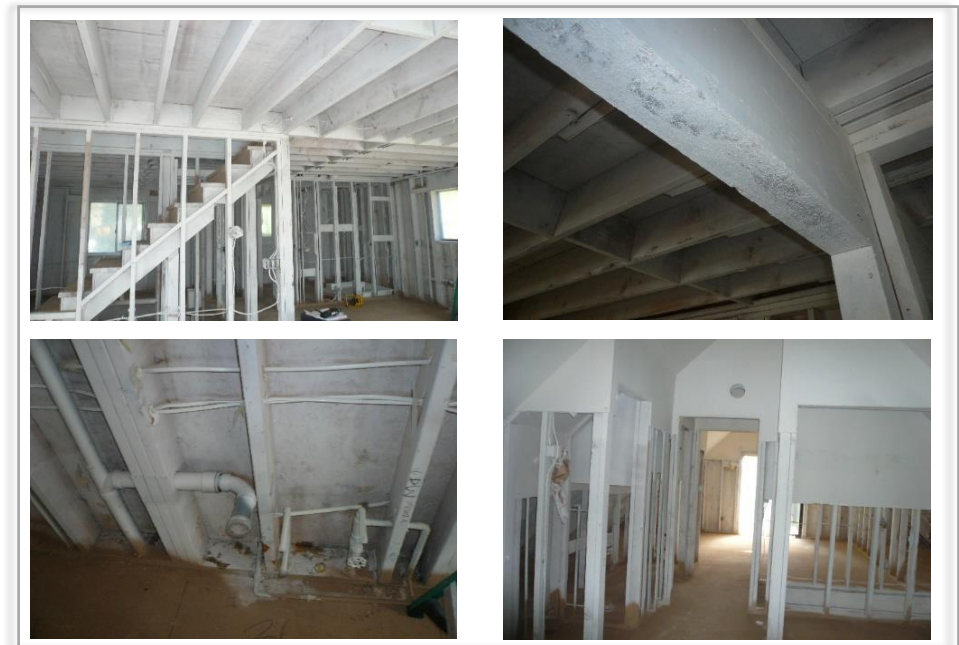
2

He had gutted the house down to the stud framing walls and applied a mold sealant, thinking he had solved the problem. Looks pretty clean, right? However, we knew just because he couldn't visibly see the mold anymore didn't mean it was gone...actually, it was still airborne.

All areas reported a “fail” in air quality. This confirmed what we already knew: the mold was still there. After a simple fogging treatment (it actually took longer to drive to the jobsite than to fog the house!), we re-tested with these results:
